# The Cadillac Serviceman

AUGUST, 1957

## BROUGHAM WINDSHIELD INSTALLATION PROCEDURE

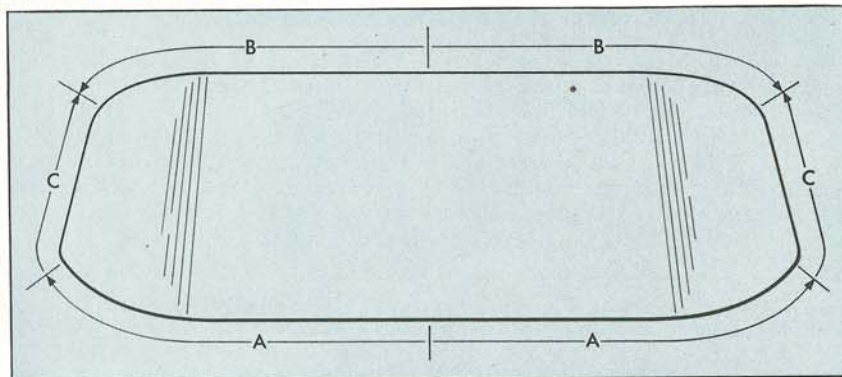
Fig. 1

A REVISION should be made in Step 5 of the Brougham windshield glass installation procedure given on Page 17-4 of the Eldorado Brougham Service Information Manual. This step concerns the string pulling sequence required to seat the rubber channel over the pinchweld flange.

NOTE: After performing Step A, make sure that the engaging lip of the windshield rubber channel is seated adjacent to the outer surface of the pinchweld flange along distances indicated by "B" and "C" in Fig. 1. This is necessary to relieve as much strain on the glass as possible and to permit easier engagement of the lip over the pinch-

Step 5 should read as follows: When glass and channel are properly positioned in the opening, slowly pull ends of cord from bottom center of windshield to seat lip of rubber channel over pinchweld flange. The string should be pulled in the following sequence:

- A. From bottom center of windshield to approximately 1" from the right and left lower corner of the windshield.

- B. From top center of windshield to right and left windshield side pillar.
- C. From right and left lower corner of windshield to upper end of windshield side pillar.

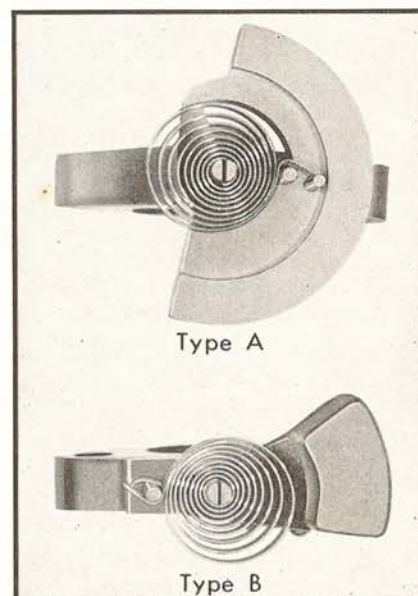
Fig. 2

ON a limited number of 1957 series cars, at approximately Engine Number 090000, a manifold heat control valve was installed that may adversely affect engine performance and contribute in some degree to carburetion difficulties such as poor performance during warm-up. This control valve, type "B" as shown in Fig. 2, has a different spring calibration than the standard 1957 control valve, and the valve bore is smaller in diameter. There is also a possibility of mechanical interference between the valve counterweight and adjacent engine parts.

On any lubrication or tune-up job, and in any case of a performance complaint, the operation of this important valve should be checked. If the type "B" valve is found, replace it with type "A", shown in Fig. 2, which is the standard 1957 manifold heat control valve, Part No. 3510508.

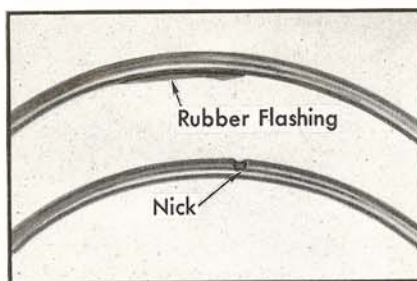
Fig. 3

**I**N many cases, oil leaks at the rear wheel bearing on 1957 series cars have been discovered to be caused by a defective "O" ring. If the "O" ring,

which is located between the bearing and housing, contains rubber flashing or nicks, as shown in Fig. 3, leakage will eventually result.

Inspection at the factory of returned parts indicates a high number of bearings, wheel bearing seals, and "O" rings are being replaced unnecessarily in the field. When faced with a report of an oil leak at the rear wheel, Servicemen are requested to make a thorough and careful inspection for the cause of leakage before replacing any parts.

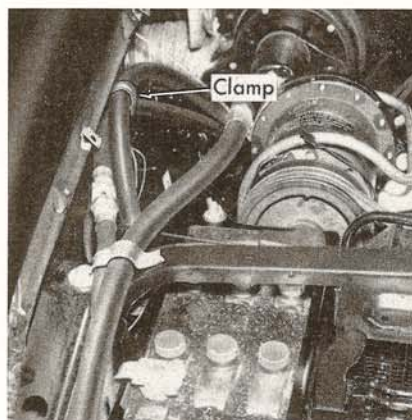
Fig. 4

Servicemen should check the position of the low pressure hose on all 75 series cars, after Engine No. 044576, to be sure that it does not contact the right hand exhaust manifold. If contact occurs, damage to the low pres-

sure hose can result, which could allow Freon to leak out from the evaporator return line.

When the hose is found to be contacting the manifold, Servicemen should check underneath the body to make certain that the hold-down clamp, Part No. 5888086, that holds the high and low pressure lines hoses, is securely in place. This clamp should be positioned at the number two body mounting bracket on the right side and attached to the underbody. Without this clamp to secure the hoses, excess slack may result, allowing the low pressure hose to contact the exhaust manifold. Secure the hoses in the clamp or install a clamp if necessary to correct the condition. Also, be sure that the clamp on the right fender, inside of the hood, holds the hoses securely, as shown in Fig. 4.
