Cadillac

SERVICEMAN

DECEMBER, 1957

IMPROVED TYPE POWER VENTILATOR WINDOW REGULATOR

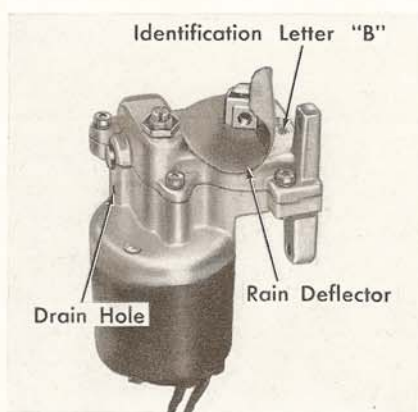
Fig. 1

On 1958 cars prior to the above Engine Number, the electric regulator assembly has been reported to fill with water. This accumulation of water and an emulsion of soluble grease from the gear box in the electric motor may have a corrosive

effect, which will cause electrical failure of the motor.

Identification of early and late assemblies must be made by inspection of the code letter adjacent to the date code, as shown in Fig. 1. Code letter "B" designates the late type, as compared to the letter "A" on the early type. Part Numbers remain 4719528 right, and 4719529 left, as originally released.

An improved type electric ventilator window regulator assembly has been developed to resist entry of rain water through the gear box, and is incorporated in 1958 cars equipped with this option, after Engine Number 009858. The improved type, now available from the factory Parts Warehouse, should be installed on all cars equipped with the original type during the owner's next routine service visit.

The late type ventilator regulator assembly incorporates design improvements to prevent this condition, including: rain deflector washer; waterproof, non-corrosive grease in the gear box; an overlap at the split line of the motor shell; undercoating material over the entire motor assembly; and drain holes on lower sides of gear box and motor.

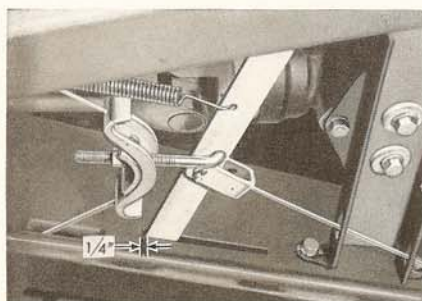
ANUMBER of reports have been received from the field concerning incomplete release of the parking brake assembly when the release pedal has been depressed. When this occurs, the pedal must be pulled up by hand to release the parking brake.

The majority of these cases can be corrected by performing the Parking Brake Adjustment as described in Section 8, Note 4 of the 1958 Cadillac Shop Manual Supplement. When adjusting the distance from the rear relay lever to the end of the slot in

the frame side member, add an additional $\frac{1}{8}$ ", making the total distance $\frac{1}{4}$ " as shown in Fig. 2 rather than $\frac{1}{8}$ " as specified in the Shop Manual.

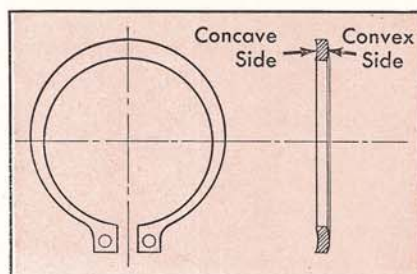
Fig. 6

Extreme care should be used when installing any snap ring of the Truarc type used in the Hydra-Matic transmission. These snap rings are convex on one side and concave on the other, as shown in the cross section illustration,

Fig. 6, and must be installed properly to assure maximum holding force.

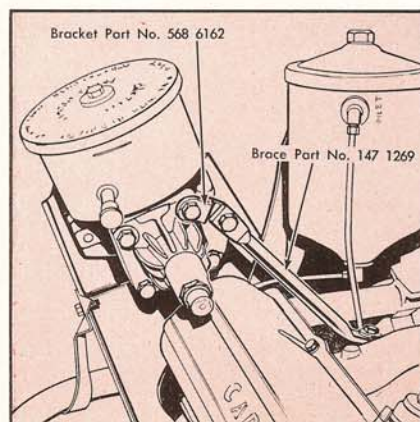
Fig. 8

AN extremely noticeable vibration similar to a "growl" has been reported at about 1000 RPM on some early production 1958 series cars. This vibration is prevented on later

production cars by a power steering pump rear brace, Part Number 1471269, with attaching bracket, Part Number 5686162, as shown in Fig. 8. However, this brace did not reach production until Engine Number 003214 on cars equipped with coil springs. A similar brace and bracket has been installed on all Air Suspension cars since the beginning of production.

An installation kit, Part Number 3631146, has been shipped by the factory as a shortage item for all coil spring cars prior to Engine Number 003214. This kit contains the brace, bracket, bolts, nut and washer necessary to install the needed brace.

If a similar vibration is noted on any car already equipped with this brace, then check the exhaust system carefully for proper alignment.
