The Cadillac Serviceman

JULY, 1957

ATTENTION TO DETAIL ASSISTS IN CORRECTING BRAKE PULL

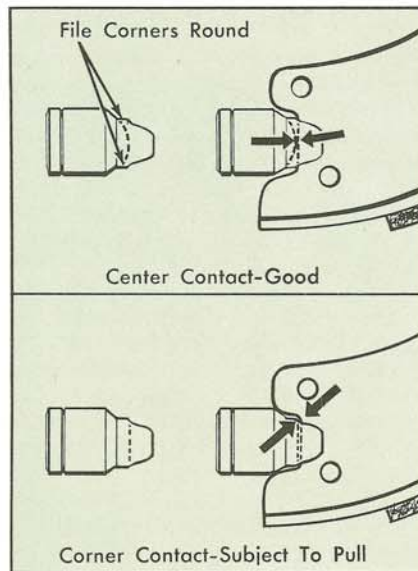
FIG. 1

Another possibility for heavy-effort pull is off-center contact between starwheel adjuster and brake shoe web, or pinching of the adjuster by the shoe, as illustrated in Fig. 1.

It may be necessary to file the brake shoe web for sufficient clearance, or file the base of each adjuster slot to provide sufficient "crown" for contact at the center of the adjuster slot. The point of contact between shoes and adjuster influences the amount of self-energization of the brake, which must be identical on both sides to avoid brake pull.

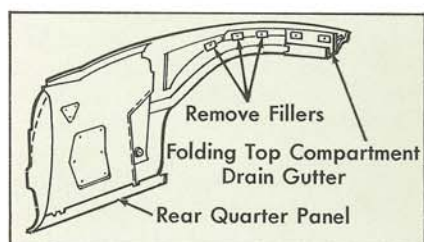
FIG. 2

IF a gap between the folding top material and the rear quarter pinchweld finishing molding presents an objectionable appearance, or allows an excessive amount of water to be directed into the folding top compartment drain gutter on 1957 Convertible styles, the following procedure should be performed to correct the condition:

1. Detach the folding top compartment bag from the rear seat back panel, and check the outer ends of the rear trim stick assembly for rubber fillers between the trim stick and inner panel. See Fig. 2. If the fillers are present,

remove the trim stick outer attaching screws and the fillers.

NOTE: On early production bodies with 11 trim stick attaching screws and fillers, remove the 2 outer fillers from each end of the trim stick. On later production bodies with 13 trim stick attaching screws and fillers, remove the 3 outer fillers from each end of the trim stick.
