The Cadillac Serviceman

JUNE, 1957

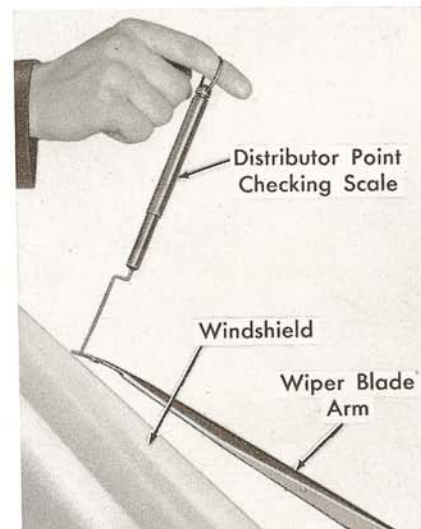
Fig. 2

THERE may be instances on some 1957 cars where the windshield wiper blades leave an unwiped area when the car is traveling at high speeds, as the force of the wind tends to lift the blades off of the glass. A contributing cause, however, could be insufficient tension in the spring joint of the wiper arm.

Whenever Servicemen encounter complaints relating to this condition, the wiper arm tension should be checked as follows:

1. Remove the windshield wiper blade.
2. Position the windshield wiper arm at the center of its travel.

3. Hook a distributor point checking scale under the tip of the wiper arm as shown in Fig. 2. Pull upward on the checking scale, and note the reading on the scale at the instant the arm leaves the glass. If the reading noted is not within the required specification of 10½ to 12½ oz., the wiper arm should be replaced.

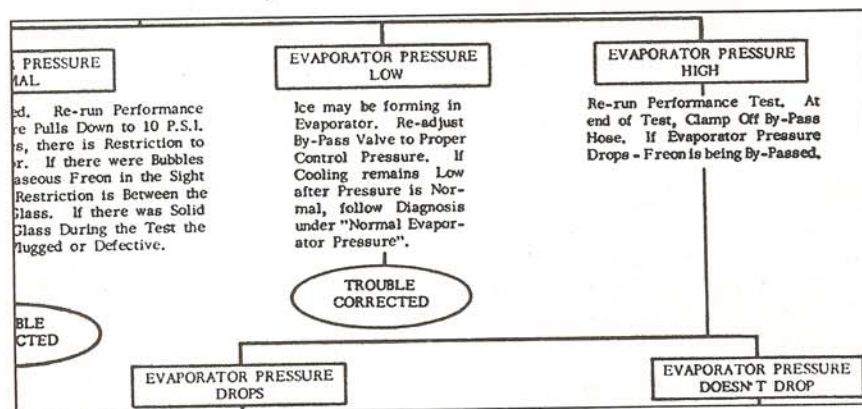
Fig. 1

A CORRECTION is necessary in the Air Conditioner Diagnosis Chart which appears on Page 13-6 of the Eldorado Brougham Service Information Manual, and in Fig. 4 of the April 24 Serviceman Supplement.

The Diagnosis Chart lists "Trouble Corrected" under "Evaporator Pres-

sure High". However, this is an error, for the chart should indicate "Trouble Corrected" under "Evaporator Pressure Low", as shown in Fig. 1.

To assure an accurate air conditioner diagnosis, Servicemen should make this correction in the above mentioned publications.

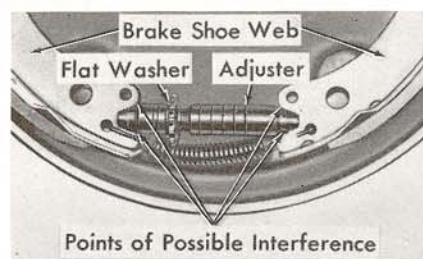
Fig. 3

IN cases of owner complaint on brake squeak in 1957 cars, Servicemen should check for proper functioning of the special, flat spring washer in the star wheel adjuster.

The adjuster screw has a recess in the face of the star wheel into which the washer flexes as the brakes are applied. If the washer is not up to the required hardness specification, it

may become permanently distorted and fail to flex as prescribed. If, upon examination, the washer is not perfectly flat, it should be replaced.

Another important factor that may cause the brakes to squeak is insufficient clearance between the brake shoe webs and the star wheel adjuster, as illustrated in Fig. 3. This interference can cause the brake shoe webs to bind the adjuster and prevent the flat washer from functioning. This condition may be corrected by filing the brake shoe webs to provide adequate clearance at the adjuster.

The washer, Part No. 5456106, is available separately from the factory Parts Warehouse, and is also included in the Brake Shoe Adjuster Kit, Part No. 5456379.

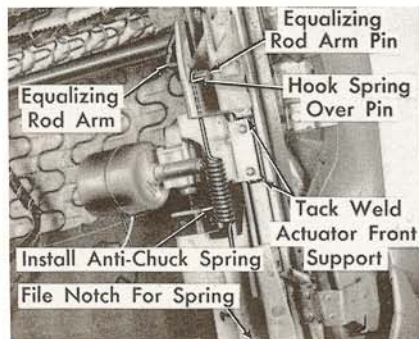
Fig. 4

IF objectionable "chucking", or fore and aft movement of the front seat, is encountered on 1957 cars equipped with electric horizontal seat adjusters, anti-chuck springs, Part No. 4734125, should be installed as follows:

1. Remove seat side panels. Install an anti-chuck spring, Part No. 4734125, at both the right and left seat adjuster, as shown in Fig. 4. NOTE: File notch for spring in rear leg of adjuster approximately $\frac{1}{2}$ " up from bottom of leg.
2. Check operation of seat adjusters, and check for seat chucking. If chucking condition has been satisfactorily corrected, install seat side panels.

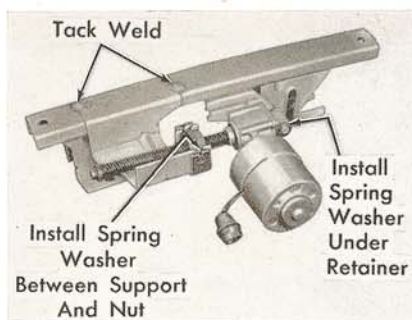
Fig. 5

If chucking still exists to an extent not acceptable to the owner, the following additional steps may be performed:

1. Operate seat to a position midway between extreme forward and rearward positions.
2. Remove seat assembly, including seat adjusters, and place assembly upside down on a protected surface. Remove tension spring at right adjuster. Remove anti-chuck spring at both adjusters. Remove left adjuster, including actuator assembly, from seat. Remove equalizing rod from seat.

3. Place equalizing rod in vise. Check arm and pin (shown in Fig. 4) on each end of equalizing rod for looseness, and if loose, weld securely.
4. On the left seat adjuster, tack weld (arc weld) the actuator front and rear supports, as shown in Fig. 4 and Fig. 5.
5. Install spring (wavy) washer, Part No. 4574152, between actuator rear support and jack screw nut, as indicated in Fig. 5.
6. Install spring (wavy) washer, Part No. 4574152, between actuator and retainer at actuator front support, as shown in Fig. 5.
7. Install and center equalizing rod. If necessary, install flat fiber or metal washer(s) on equalizing rod support pins, between support and arm of equalizing rod, to properly center rod.
8. Install left seat adjuster tension spring and anti-chuck springs, and install seat assembly.
9. Check operation of seat assembly.

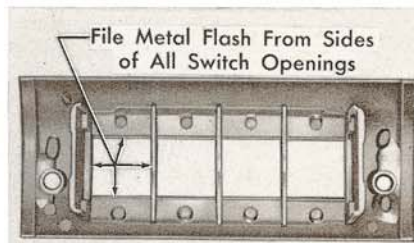
Fig. 6

IN several cases of sticking power window master switches recently investigated, it was found that the upper or lower edge of the switch escutcheon opening did not allow sufficient clearance for the curved surface of the switch lever.

Although binding was not noticeable through mid-travel of the switch, the edge of the switch lever was found to catch on the edge of the escutcheon opening at extreme "up" or "down" positions.

A simple correction for this condition can be performed by using a distributor point file to clean off extra casting flash from the edges of the escutcheon openings as shown in Fig. 6. This requires removal of the switch from the escutcheon, to avoid getting metal filings in the switch. When the switch assembly has been removed from the car, the switch can

easily be removed from the escutcheon by disengaging four spring tangs of the retainer clips at either end of the switch. Filing can be done on the escutcheon at such an angle that the file marks are not visible from the outer side, and the filed surface will then be approximately parallel to the curved surface of each switch lever. As a protective measure against file marks, masking tape should be placed over the finished surfaces at the outer edges of the escutcheon.

Always check to see that the switch cover plate is securely attached to the plastic housing, as a loose cover would also cause the switches to stick.
