The Cadillac Serviceman

MAY, 1957

POSITION BATTERY CABLE RETAINER CLIP CORRECTLY

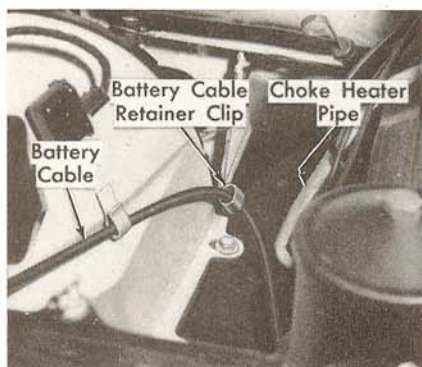
Fig. 1

ON early model 1957 series cars, the battery cable retainer clip on the right front fender inner dust shield was incorrectly positioned. As a result, the battery cable might contact the choke heater pipe, which might burn away the insulation and cause a short circuit in the battery cable.

To remedy this condition in production, effective with Engine No. 055227, the battery retainer clip has been turned inward as illustrated in Fig. 1. This will allow more clearance between the battery cable and the choke heater pipe.

When performing any work underneath the hood on cars built previous to Engine No. 055227, Servicemen should bend the battery cable retainer clip sufficiently to obtain adequate clearance at the choke heater pipe.

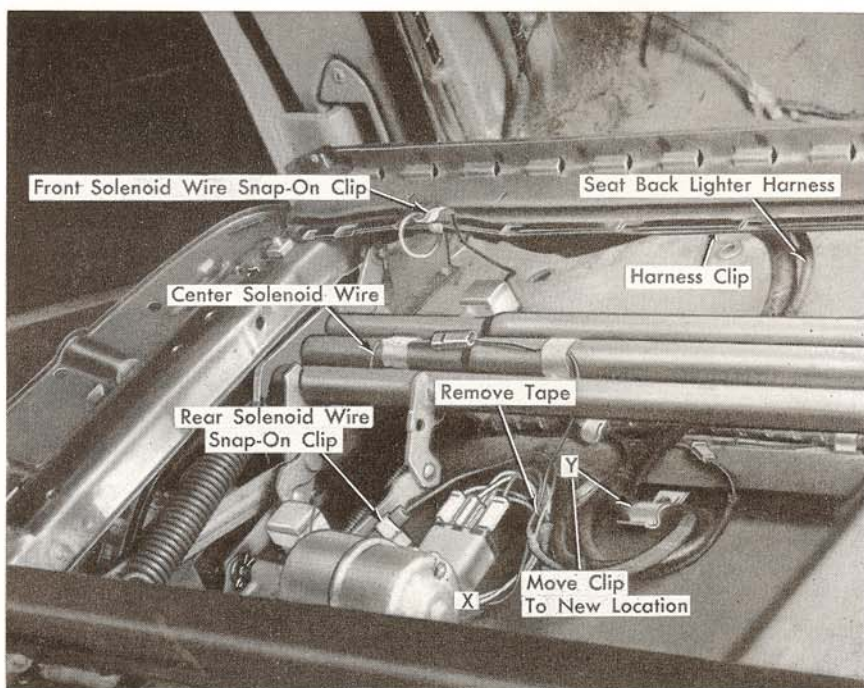
Fig. 2

WHENEVER wiring interference is encountered in the six-way seat adjuster mechanism, or if the seat adjuster control wiring is disturbed during service operations on 1957 series 60 and 62 style cars, the following instructions should be observed:

1. Remove front seat assembly (Refer to Section 17, Note 85 of the 1957 Shop Manual).
2. Check to see that the rear solenoid connector is installed under snap-on clip, as shown in Fig. 2.

3. Where present, remove snap-on clip securing front solenoid wire to adjuster linkage. Tape solenoid wire and lead wire to the center torque tube, as in Fig. 2.

4. The location of the wire harness clips on the floor pan should be checked. If clips are present at locations "X" and "Y", as in Fig. 2, remove clip at location "X" and move clip at location "Y" to new position, shown in Fig. 2. This new location should position the clip away from the front of the actuator motor, while keeping it in the area between the front and rear floor carpets.

9. Connect harness to lead wires. Install front solenoid wire connector and snap-on clip to inner flange of seat bottom frame as illustrated in Fig. 2.

10. Operate seat assembly to the full "forward" and "up" position. Wire harness should be positioned under newly located clip "Y" on floor pan, to take up slack in wire harness between the seat and clip on floor pan.

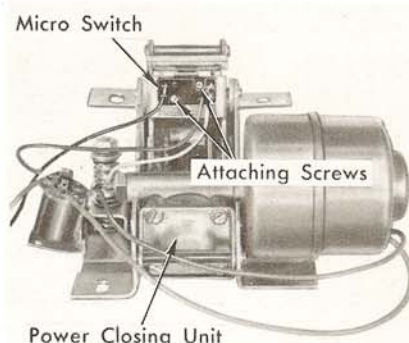
Fig. 3

REPLACEMENT of the complete automatic deck lid lock assembly because of damage to the micro switch is no longer necessary. The micro switch is now available through the factory Parts Warehouse for service replacement. The part number of the micro switch for 1957 cars is 4902033.

An inoperative micro switch is, in most cases, due to misalignment of the deck lid or mispositioning of the deck lid lock unit. If either situation exists, the deck lid lock may not engage the lock striker properly as the deck lid is closed, resulting in damage to the switch.

To replace the switch, unsolder the wire leads at the switch, Fig. 3, and remove the two attaching screws. Install the new switch and reattach the wire leads, making certain that they are connected to the correct terminals.

After installing a new switch, check the deck lid and deck lid lock unit adjustments. Refer to Notes 108 and 111 in Section 17 of the 1957 Shop Manual.

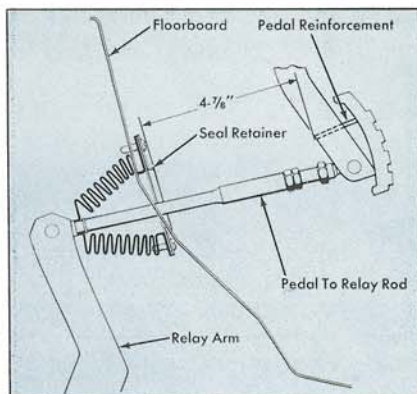
Fig. 4

MEASUREMENT of brake pedal travel as illustrated in Fig. 8-5 of the 1957 Shop Manual is incorrect. The $4\frac{7}{8}$ " measurement between the seal retainer and the pedal reinforcement should be taken between the points indicated in Fig. 4.

Each Serviceman should correct the illustration in his copy of the Shop Manual, to assure correct measurement for this important adjustment.
