# The Cadillac Serviceman

VOLUME XXXI

No. 10

OCTOBER, 1957

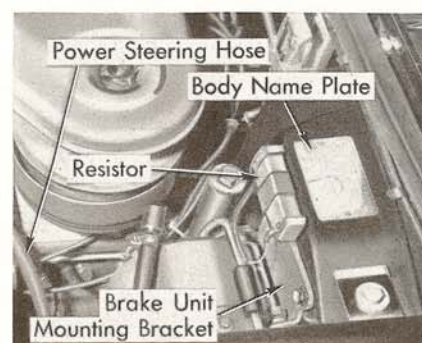
Fig. 1

Early in 1957 production, the left hand heater blower motor resistor on the Brougham was changed to a new location to eliminate any possibility of the left hand air cleaner making contact with the resistor at the wire terminals.

The resistor should be installed parallel to the body name plate as illustrated in Fig. 1. If the resistor has not been relocated on any early 1957 Brougham, then any Serviceman is authorized by the factory to make this change. In doing so, the procedure as outlined on Page 27 of the March, 1957 issue of the "Serviceman" should be carefully observed.
