The Cadillac Serviceman

SEPTEMBER, 1957

TWO TYPES OF PISTONS USED IN 1957 PRODUCTION

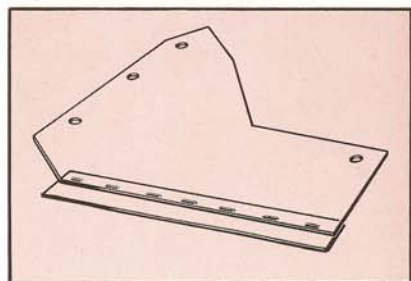
FIG. 4.

THERE have been occasional reports from the field of the radiator air deflector to front bumper seal hanging down below the bumper on some 1957 cars.

Servicemen can correct this condition by stapling a $1\frac{1}{2}$ " x $12\frac{9}{16}$ " piece of acromat to the deflector seal as shown in Fig. 4. Thus, by lengthening the seal, it can be tucked up further into the bumper, preventing any possibility of its slipping down and becoming exposed.
