Cadillac

SERVICEMAN SUPPLEMENT

No. 6 November 22, 1957

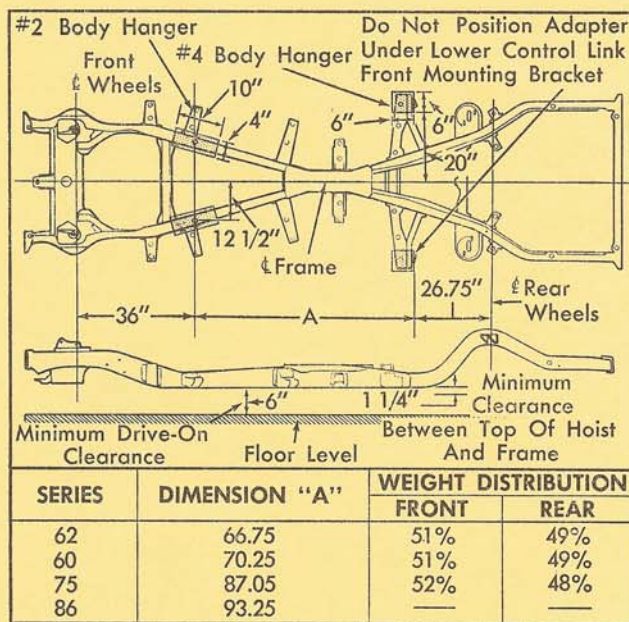
Fig. 4-7 in the Chassis Suspension Section of the 1958 Cadillac Shop Manual Supplement, and Fig. 3 in the November issue of the "Cadillac Serviceman", were published in error. Specifications for raising all 1958 Cadillac cars, except series 7059, on frame contact hoists are shown in Fig. 1 below. Written instructions remain the same as outlined in the Manual.

Only equipment that engages the suspension, axle or wheels should be used in lifting the series 75 and 86 cars. This equipment is the preferred type for lifting all Cadillac cars.
