The Cadillac Serviceman

MAY, 1957

POSITION BATTERY CABLE RETAINER CLIP CORRECTLY

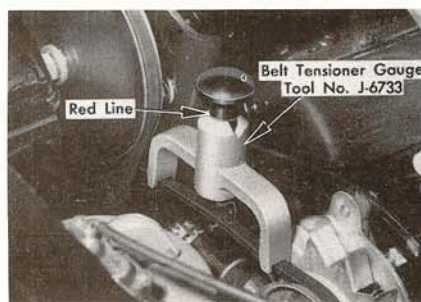
Fig. 5

The tool has been developed to meet a growing necessity for more accurate belt tensions. Use of the new tool will assist in providing better cooling and more efficient Air Conditioner operation by reducing the possibility of belt slippage. Accurate belt tensions may also materially reduce vibrations often set up by overtight-

1. Place Belt Tensioner Gauge on belt as shown in Fig. 5.
2. If the red line does not line up with gauge shoulder, as illustrated in Fig. 5, loosen the belt tension adjusting nuts and tighten or loosen belt until the red line on the barrel of the Gauge is even with the shoulder.
3. Tighten belt adjusting nuts.
