# The Cadillac Serviceman

VOLUME XXXI

No. 10

OCTOBER, 1957

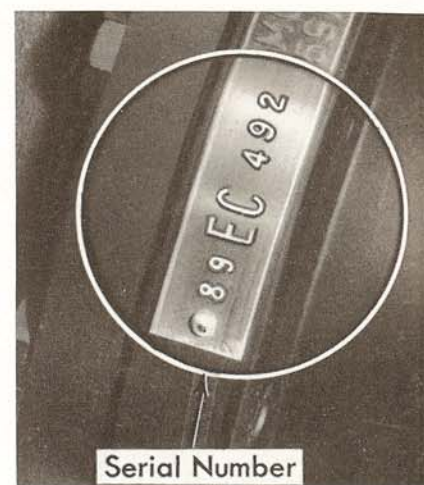
Fig. 2

There have been occasions in the past where the model number was erroneously listed in place of the serial number, causing unnecessary delay and additional paper work. Unless the correct serial number, as illustrated in the sample, Fig. 2, is listed on the AFA, the claim cannot be processed.
